Subject: Phase I Environmental Assessment Summary  
Laundromat Property  
1030 N. Mills Avenue  
Orlando, Florida

**Phase I Environmental Assessment  
Coin Laundromat  
1030 North Mills Avenue  
Orlando, Orange County, Florida**

Subject: Phase I Environmental Assessment  
Coin Laundromat  
1030 North Mills Avenue  
Orlando, Orange County, Florida

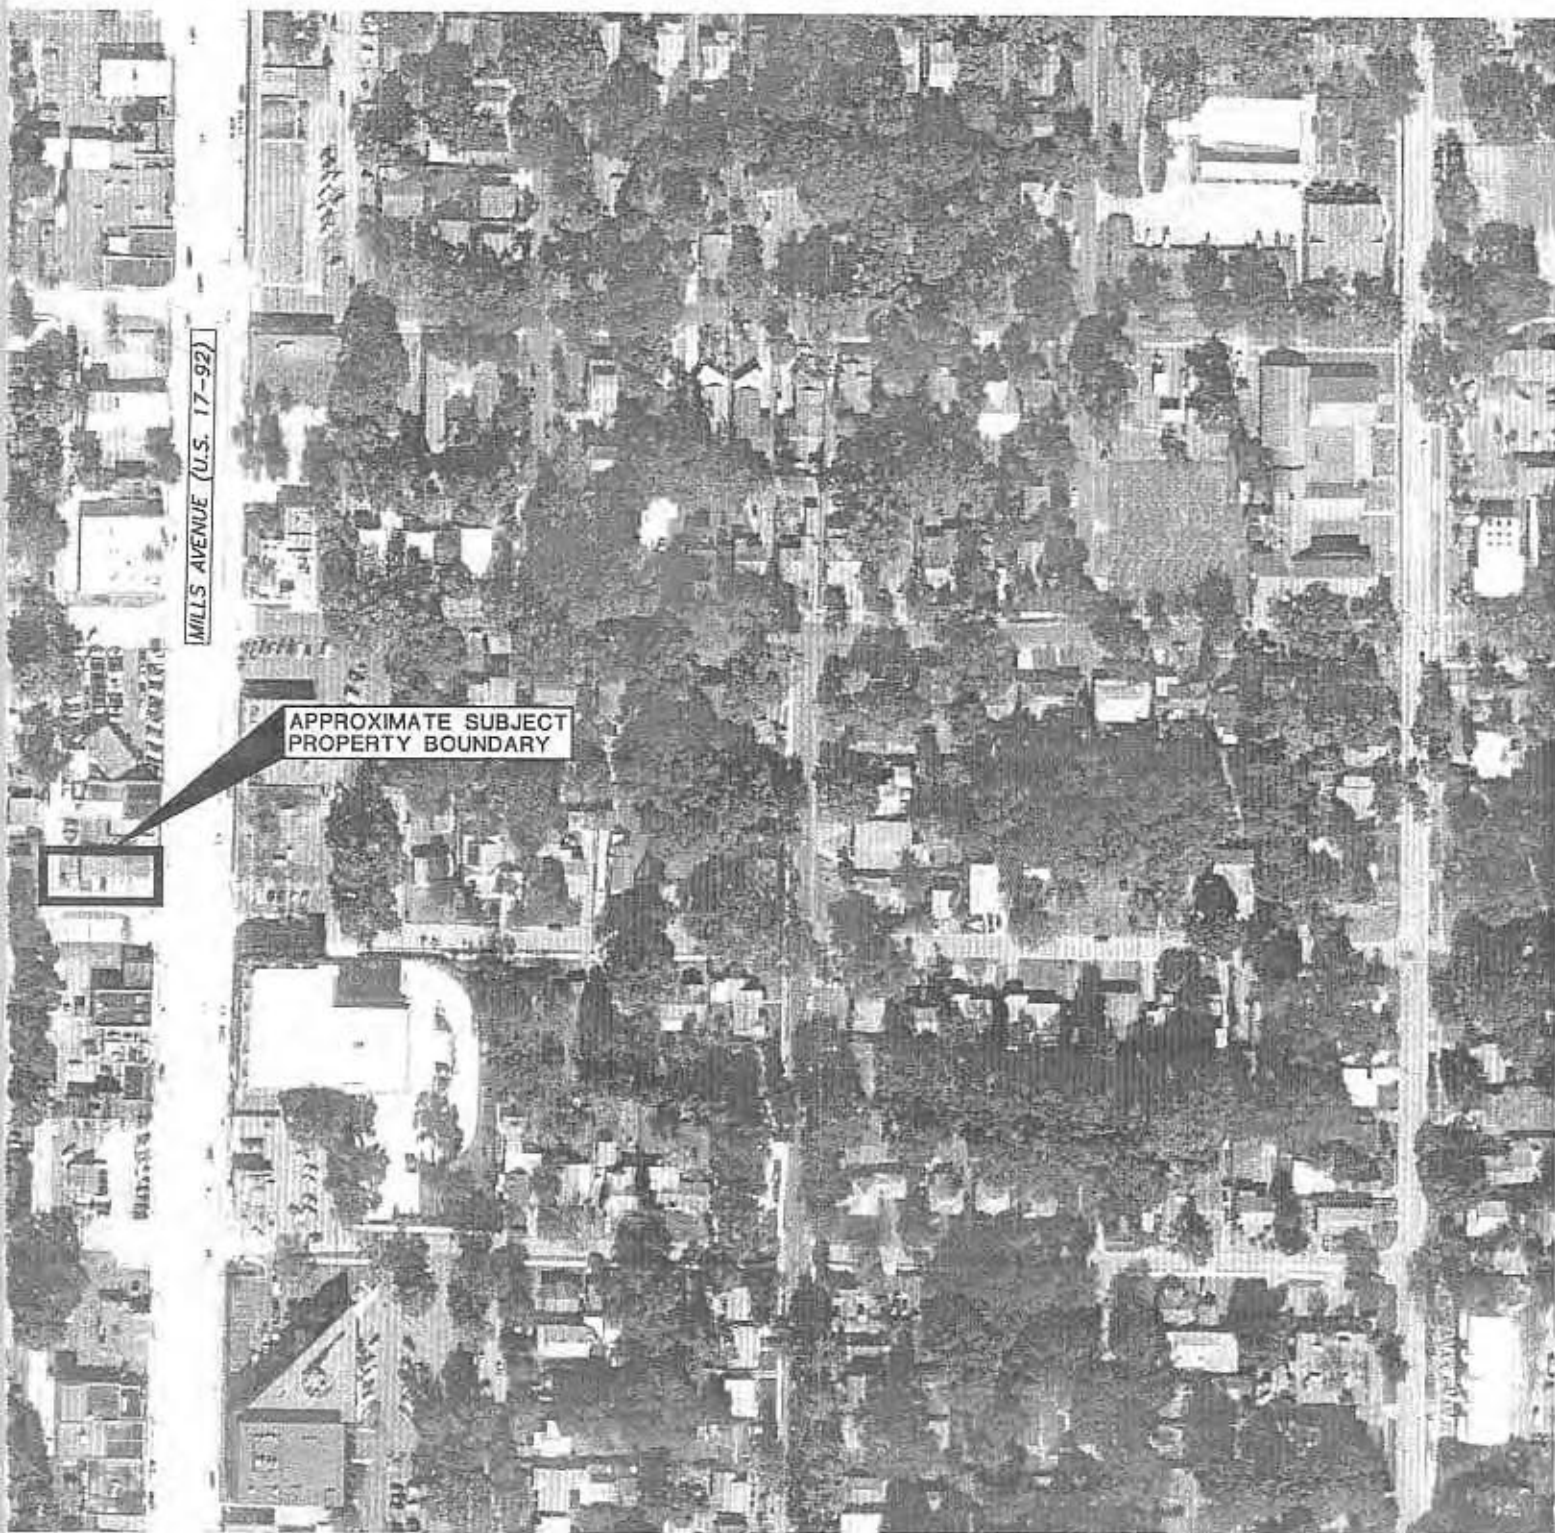
FIGURE: 2

AERIAL PHOTOGRAPH: ORANGE COUNTY, FLORIDA  
DATE: DECEMBER, 2002

**AERIAL PHOTOGRAPH  
OF SUBJECT SITE**

The subject site and adjacent properties appear essentially unchanged in the 2002 aerial photograph, with the exception that the Shurgard Storage facility to the southeast is first visible in the 2002 aerial photograph.

The site and vicinity appear similar to conditions observed during the site visit in the 2002 aerial photograph.

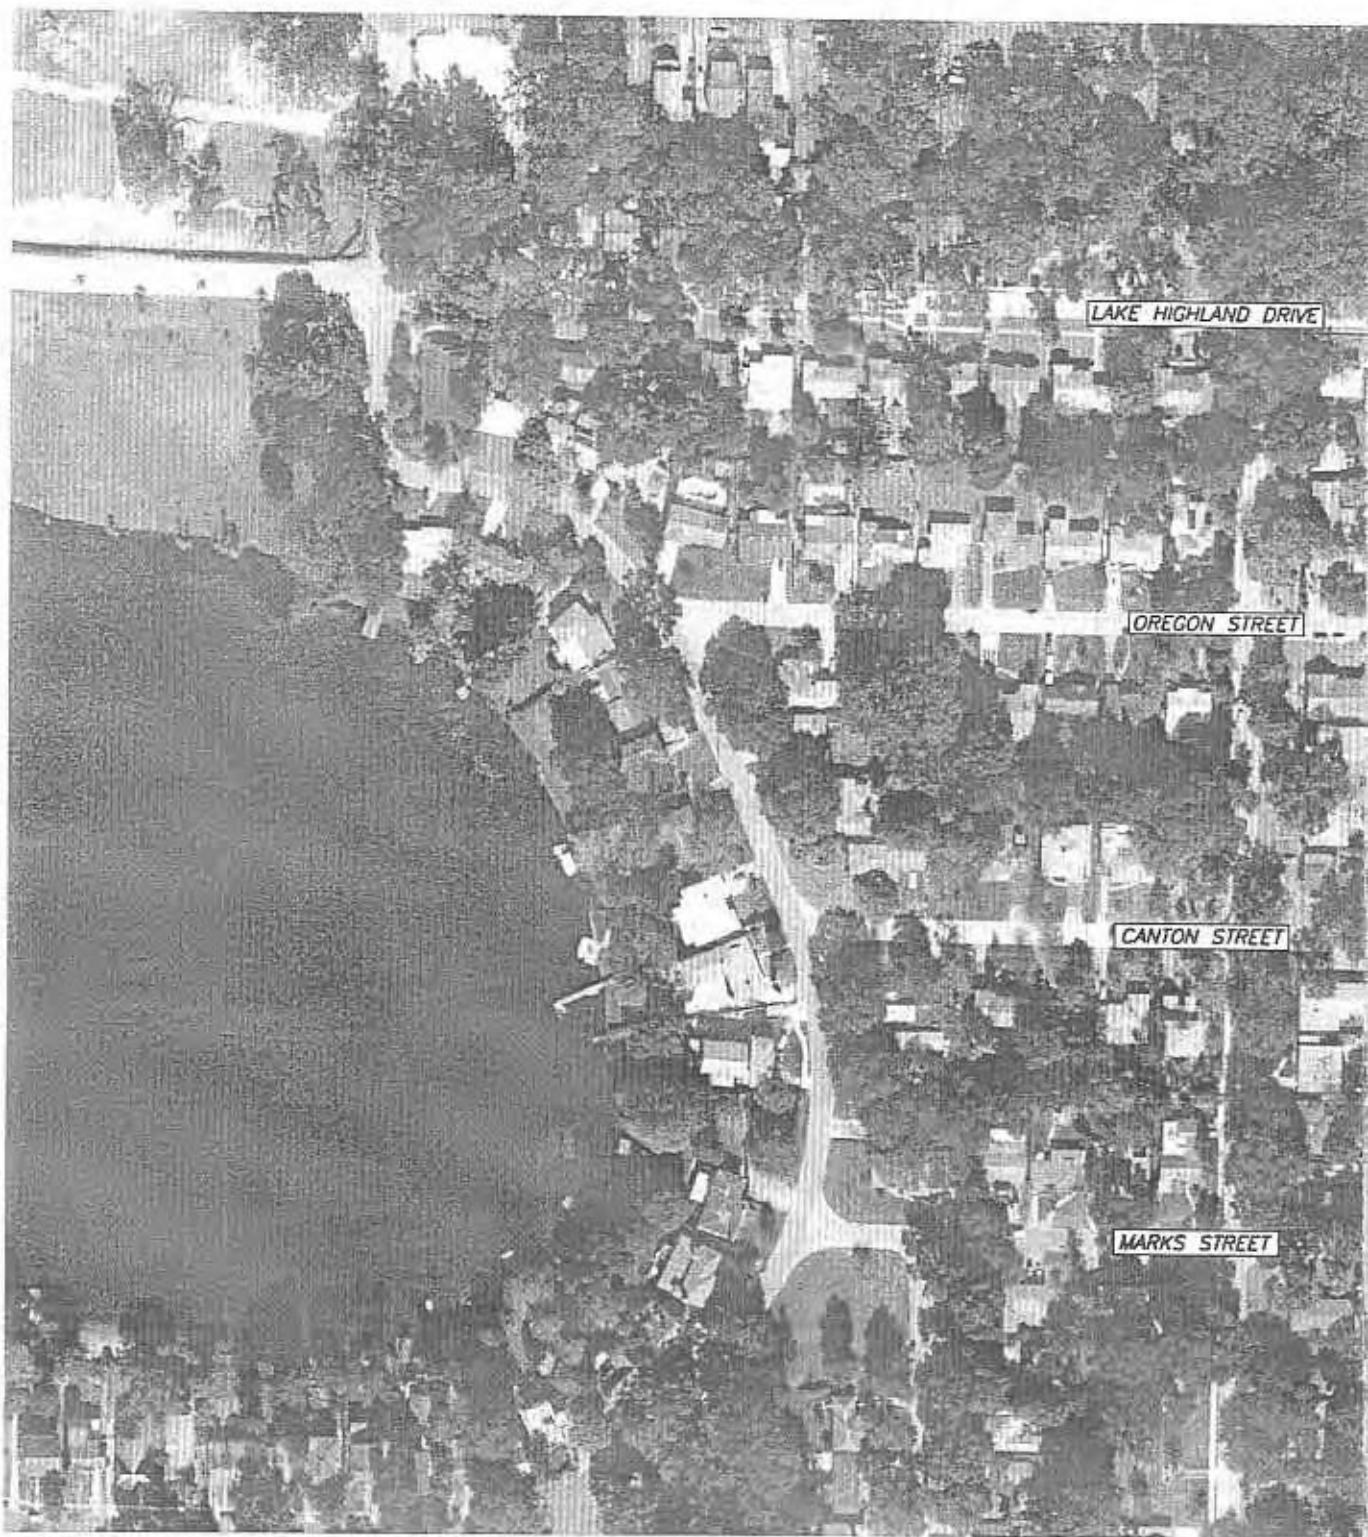
The field observations of the subject property parcels and adjacent properties were performed on July 16, 2003. Photographs of the subject property are included in Appendix II. A 2002 aerial photograph of the site vicinity is included as Figure 2.
